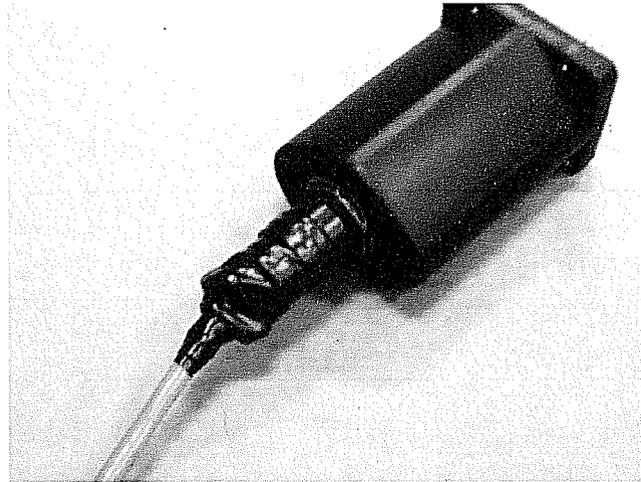
Figure 3 Poorly Done - Single Layer

Below is a poorly done tape job. The connector nut is exposed and one of the strain-relief screws has punched thru the tape. Only one layer of tape is used here.
